**EPA Region 10  
RCRA Compliance Inspection Report  
Section A**

Handler Name: Harrah Farm Shop

Inspection Date: July 23, 2009

**Report:** Photo Log

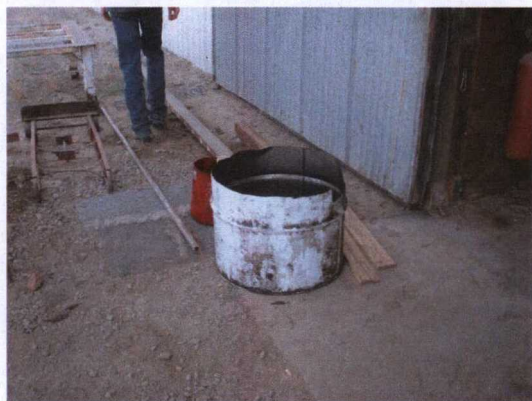
Photo #1

Mr. Hedden explained that used oil is collected in a drum and is taken offsite to be burned by Yakama Forest Products. We observed an unlabeled, cut off drum that contained what Mr. Hedden confirmed was used oil. Mr. Hedden stated that the container was supposed to be used for antifreeze but that the mechanics sometimes put used oil in it. We also observed the collection drum that Mr. Hedden said was used to accumulate used oil. It was sitting on the ground behind the shop and was not labeled. We explained that any containers of used oil should be labeled with the words "used oil". We also observed an open pan containing what appeared to be oil sitting on the ground behind the shop near the used oil collection drum. We observed that there were several oil stains on the ground around the collection drum and the open pan. We suggested that the drum and pan should be placed in some kind of secondary containment.

Unlabeled open cut off drum containing used oil.

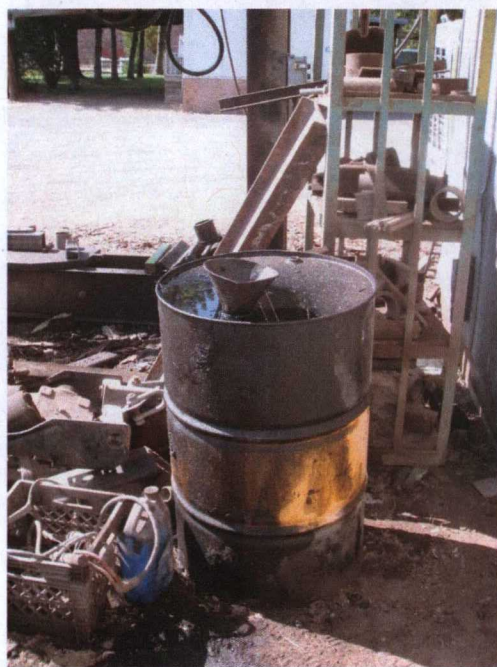
Photo #2

Unlabeled 55-gallon drum of used oil found behind the shop.

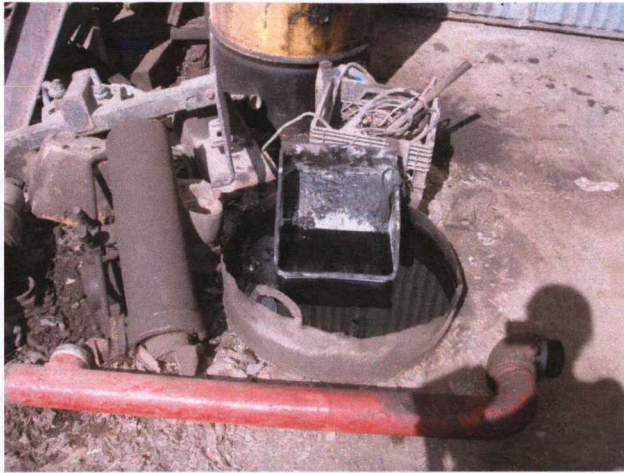
Photo #3  
Harrah Farm Shop  
Christine Sprunger  
July 23, 2009

Unlabeled open pan of used oil behind the shop. Oil stains are visible on the ground.

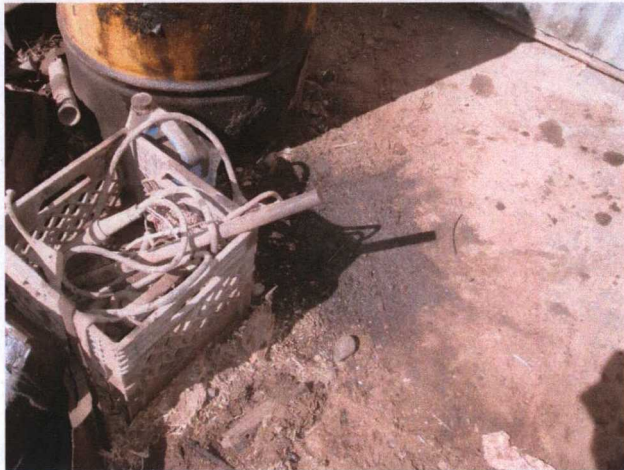
Photo #4  
Harrah Farm Shop  
Christine Sprunger  
July 23, 2009

Close up of oil stains on the ground.

Summary: The facility appeared to be a conditionally exempt small quantity generator. Containers of used oil were not labeled and used oil was being sent offsite for burning without being declared to meet specifications. Releases of used oil were not being addressed.
